# RIPARIAN AREA MANAGEMENT

TR 1737-12 1996 (Revised 1999)

*Using Aerial Photographs to Assess Proper  
Functioning Condition of Riparian-Wetland Areas*

U.S. Department of the Interior  
Bureau of Land Management

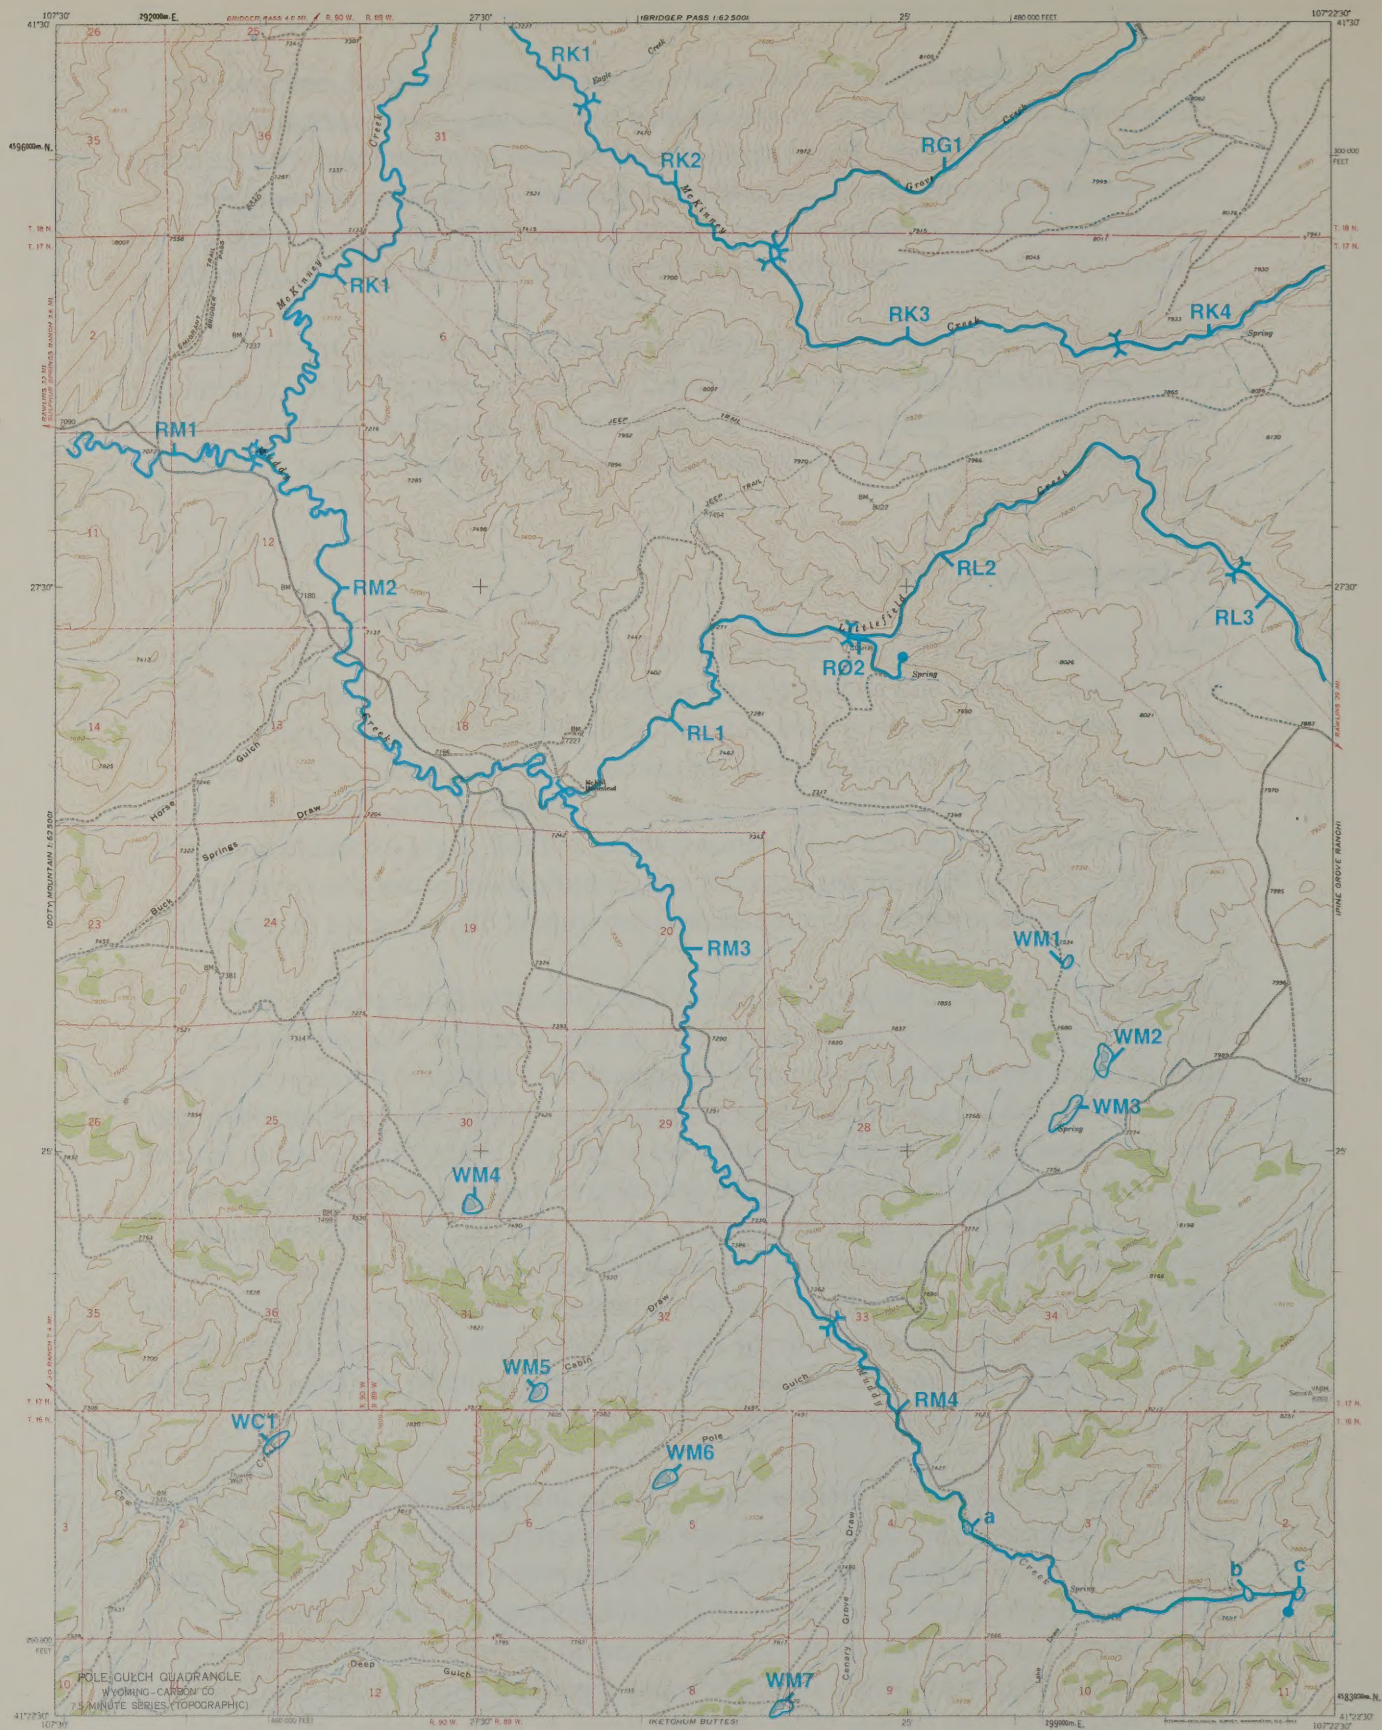
Figure 2.

Yes	No	N/A	Hydrology
x			1) Floodplain above bankfull is inundated in "relatively frequent" events
	x		2) Where beaver dams are present they are active and stable
?	?		3) Sinuosity, width/depth ratio, and gradient are in balance with the landscape setting (i.e., landform, geology, and bioclimatic region)
	x		4) Riparian-wetland area is widening or has achieved potential extent
x			5) Upland watershed is not contributing to riparian-wetland degradation
Yes	No	N/A	Vegetation
	x		6) There is diverse age-class distribution of riparian-wetland vegetation (recruitment for maintenance/recovery)
	x		7) There is diverse composition of riparian-wetland vegetation (for maintenance/recovery)
	x		8) Species present indicate maintenance of riparian-wetland soil moisture characteristics
	x		9) Streambank vegetation is comprised of those plants or plant communities that have root masses capable of withstanding high streamflow events

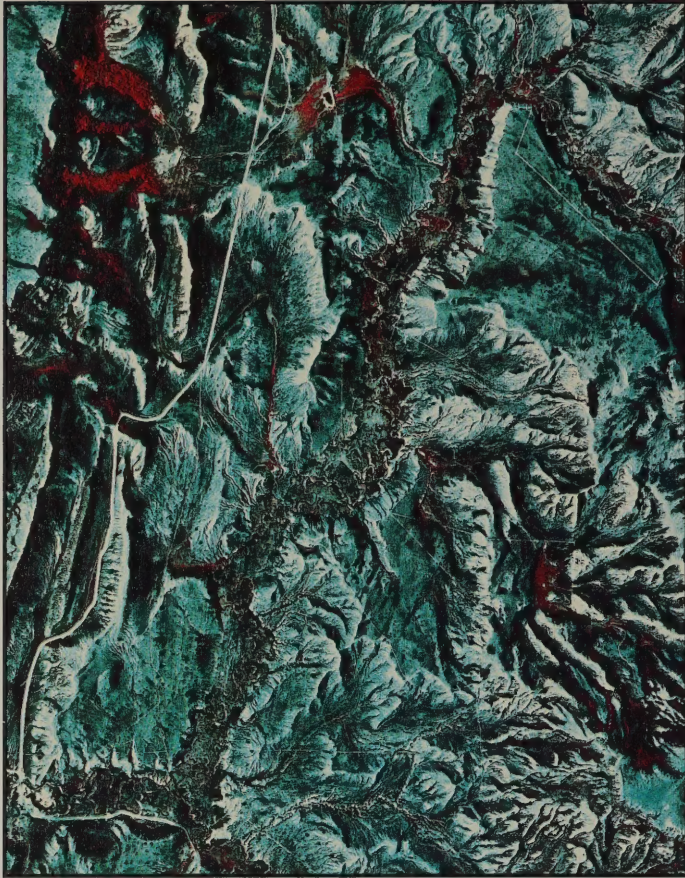
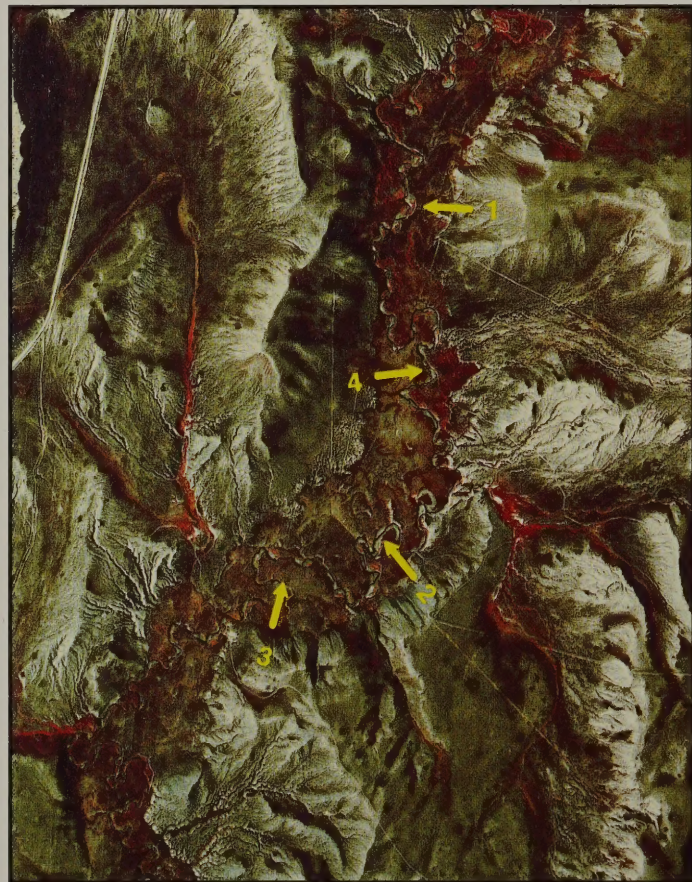
Photo 1a — July 1989

The presence of midchannel bars (arrow 4) suggests that the floodplain and channel characteristics are not adequate to dissipate energy. Deposition of materials also indicates the system is not in balance with its sediment load.

The color balance difference in the two photos should be noted. Color balance in CIR photography is difficult to control.

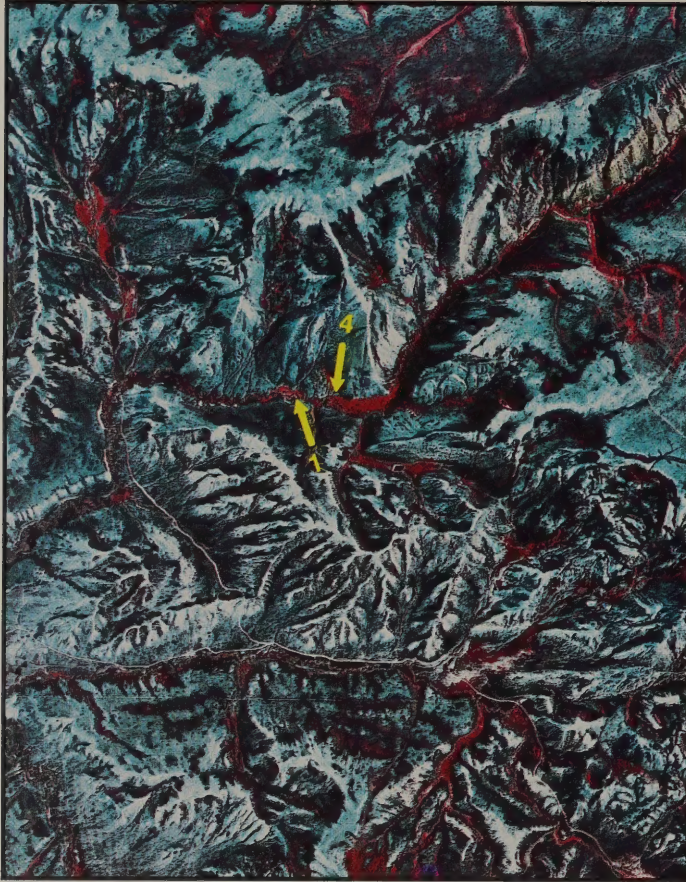
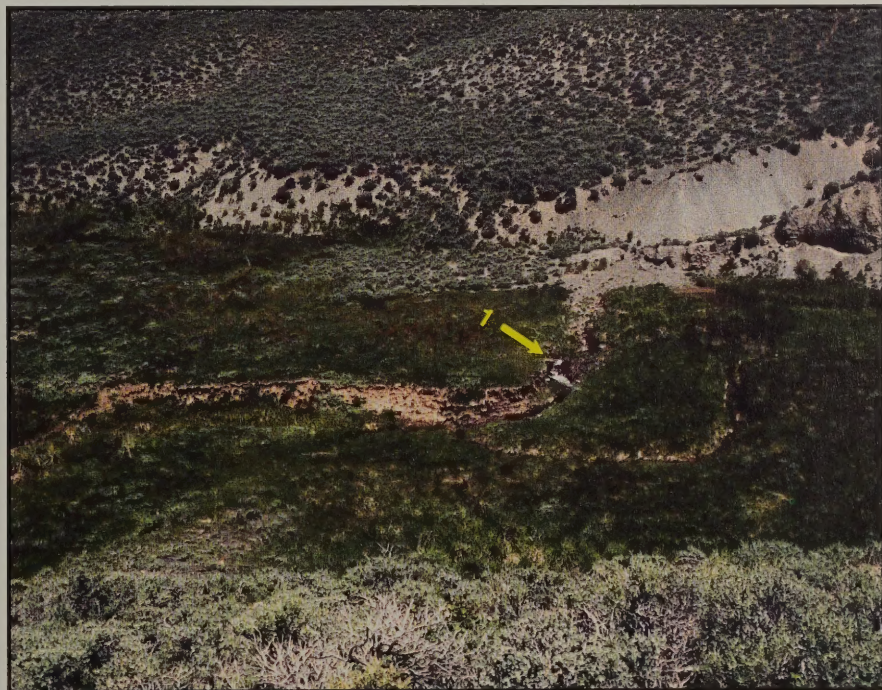
Photo 2a — July 1989

Photo 2a is a CIR photo of Littlefield Creek at a nominal scale of 1:40,000, photo 2b is a CIR photo at a nominal scale of 1:3,000, and photo 2c is a ground photo. All three photos focus on a headcut (arrow 1) that is slowly progressing upstream through a beaver complex.

This stream would be divided into two reaches, one above the headcut and one below, based on evidence in these photos. The disturbance caused by the headcut can be seen in all three photos.

Under stereo magnification, diverse age structure of vegetation (arrow 5) can be seen around the beaver ponds in aerial photos 2a and 2b. Variations in texture, height, and spectral reflectance are indicators of a diverse composition and age structure of vegetation. Some diversity can still be seen below the headcut (arrow 6). However, the mixed red, white, and blue-green signatures are indicators of upland species that have invaded the site due to lowering of its water table.

On a standard PFC checklist, items addressing vegetation above the headcut would be answered "Yes;" items addressing vegetation below the headcut would be answered "No."

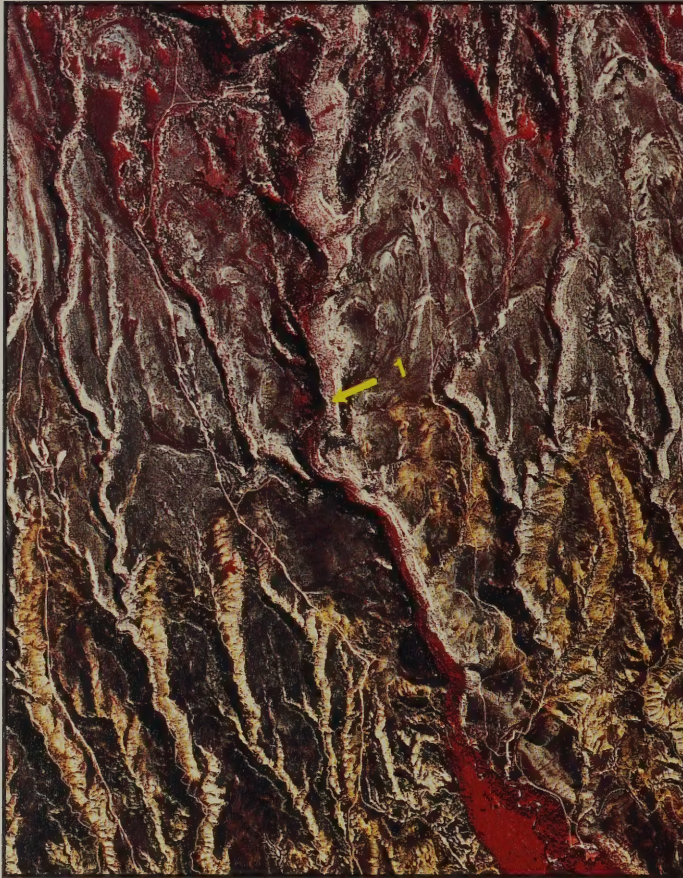
Photo 3a — July 1989

Photo 3a is a CIR photo of the Middle Fork Powder River at a nominal scale of 1:40,000. Photo 3b is a natural color photo of the same area at a nominal scale of 1:3,000. Photo 3c is a field photo taken from a ledge approximately 200 feet above the valley floor. This series of pictures shows how landform is important in determining the condition of a riparian-wetland area.

Under stereo magnification, unvegetated spots (arrow 1) can be seen in the channel in photo 3a. The slope of the valley bottom and the gradient of the stream suggest that these could be rock rather than sand, gravel, or soil bars; the other two photos confirm the presence of large rocks and possible bedrock in the channel.

Vegetation items on a PFC checklist could be answered "N/A" or "Yes" because vegetation plays a limited role in dissipating stream energy.

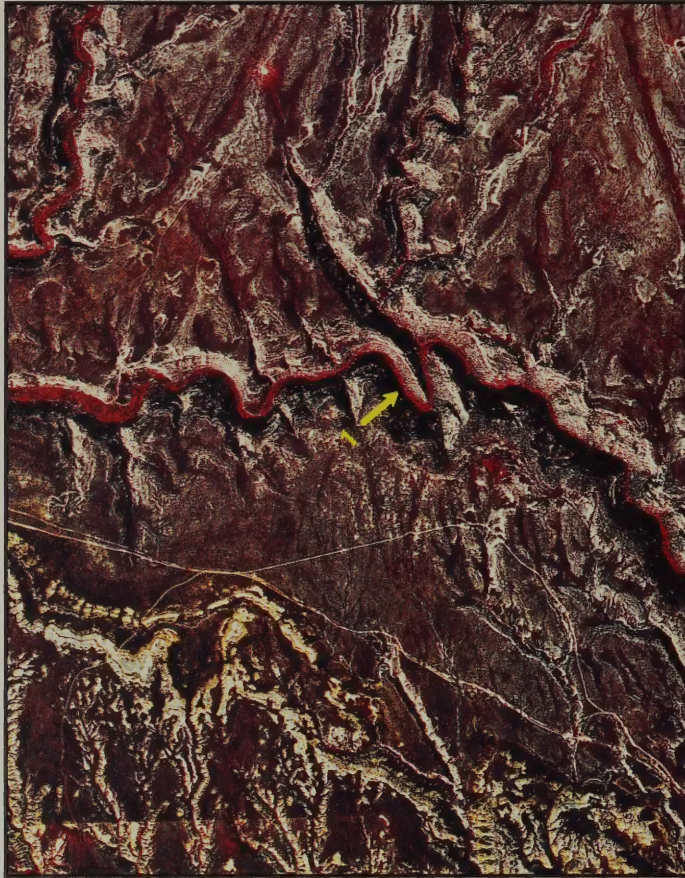
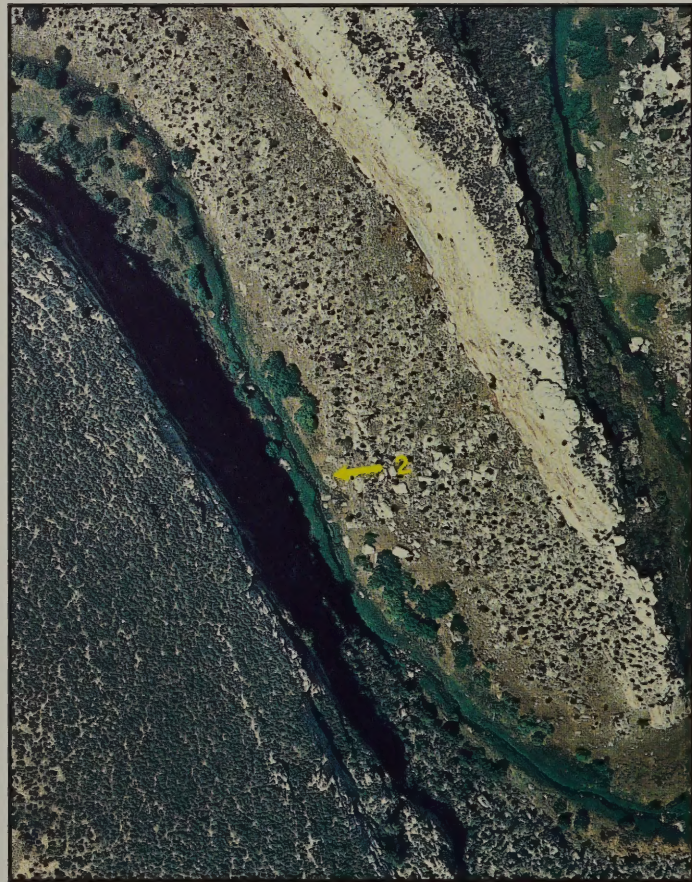
Photo 4a — June 1989

Photo 4a is a CIR photo of Buffalo Creek at a nominal scale of 1:40,000. Photo 4b is a natural color photo of the same area at a nominal scale of 1:3,000. Photo 4c is a ground photo.

Photo 4a shows a bright red signature throughout the valley floor due to a wet year (arrow 1). This would be interpreted as excellent riparian-wetland vegetation condition throughout the reach. However, an interpreter must compensate for photos that were taken while upland species are still actively growing. Photos 4b and 4c show that there is a high percentage of upland vegetation, especially grasses, growing on the streambanks (arrow 2). Upland plants do not count when deciding if there is adequate vegetation to protect streambanks. Vegetation items on a PFC checklist would be answered "No."
